*U.S. Air Force Rapid Airfield Damage Repair Modernization Program*

## **Refinement of Foam Backfill Technology for Expedient Airfield Damage Repair**

Phase II: Development of Prototype Foam Dispensing Equipment and Improved  
Tactics, Techniques and Procedures

December 2017

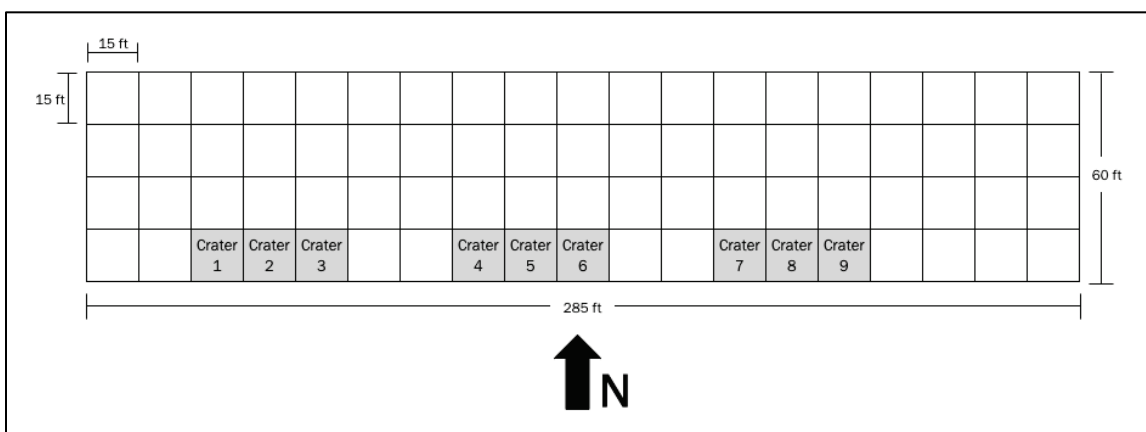
Figure 5.1. Crater layout during full-scale field testing.

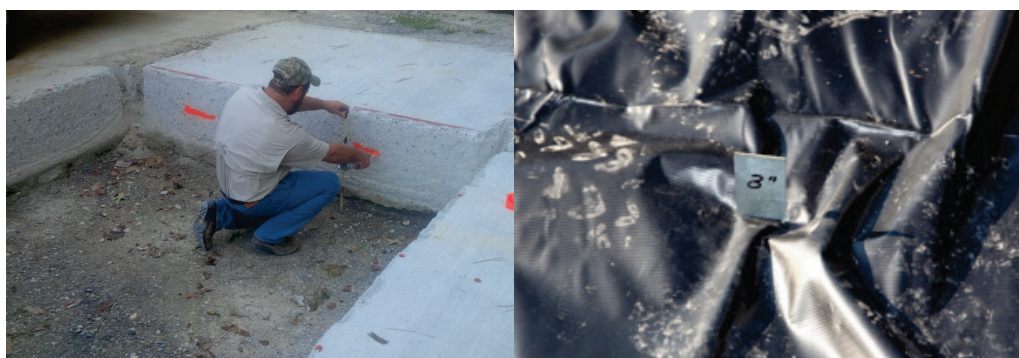
Figure 5.2. Marking required expanded foam depth on crater walls (left) and metal marker for liquid foam depth (right).

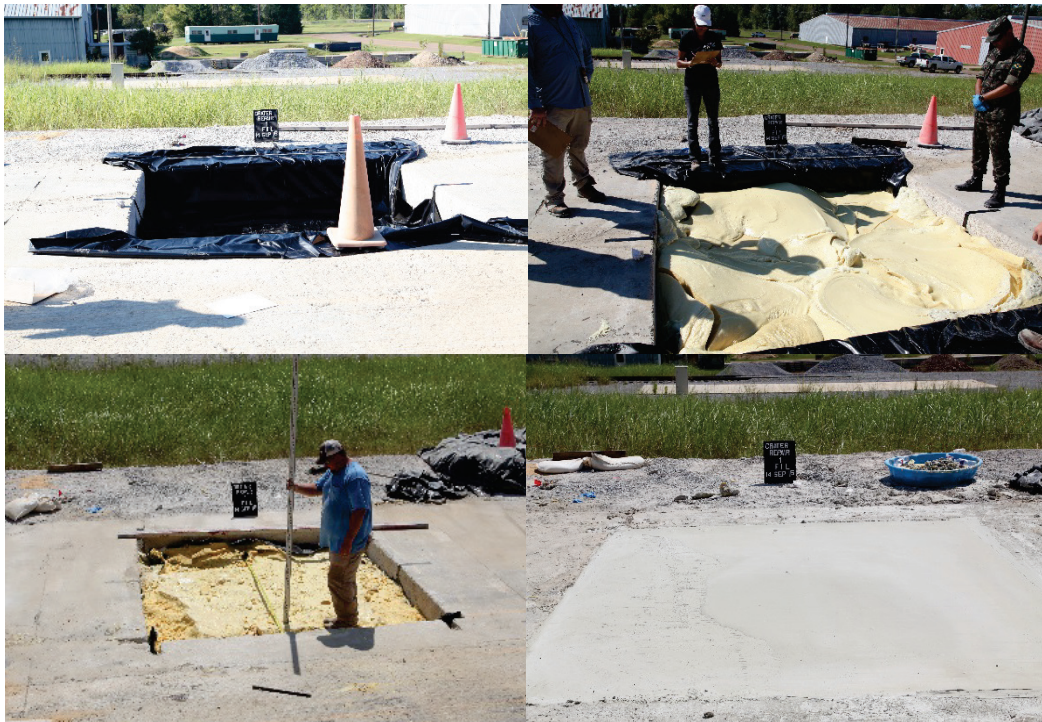
Figure 5.3. Repair sequence for Crater 1 including the crater prepared for backfilling (upper left), the crater with fully cured foam backfill (upper right), the finished foam surface ready for capping (lower left), and the completed repair (lower right).

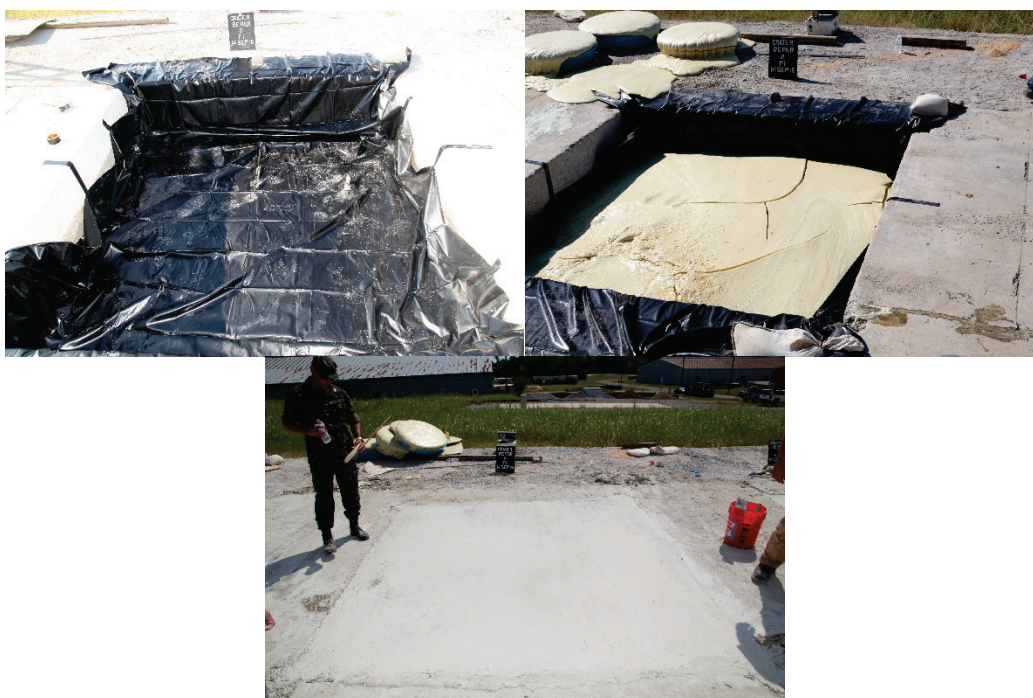
Figure 5.4. Repair sequence for Crater 2 including the crater prepared for backfilling (upper left), the crater with fully cured foam backfill (upper right), and the completed repair (lower left).

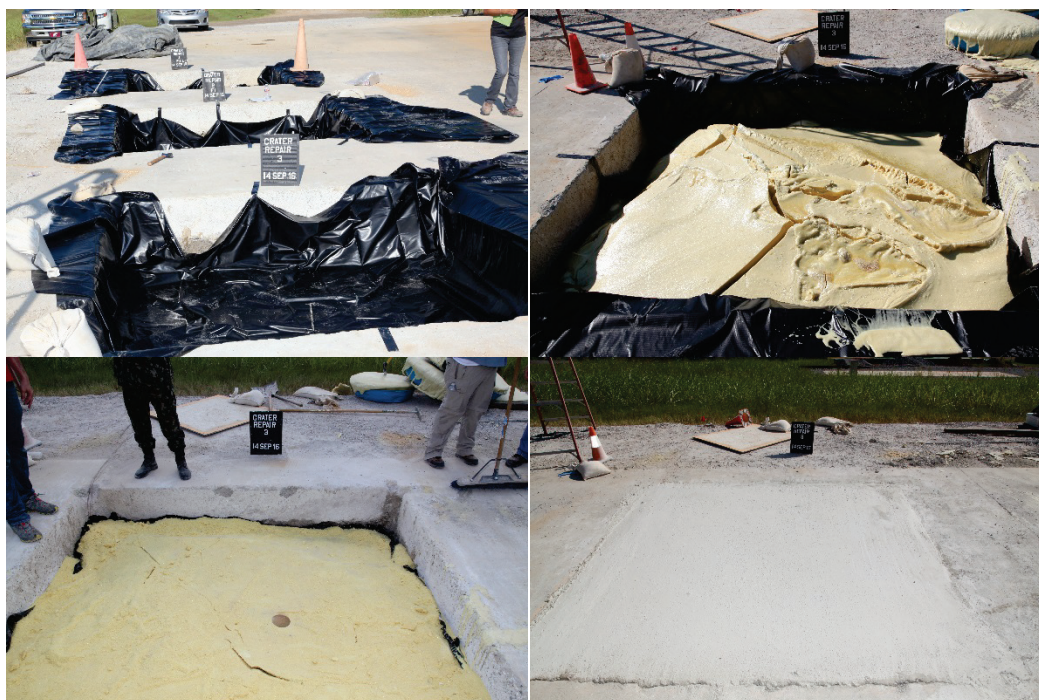
Figure 5.5. Repair sequence for Crater 3 including the crater prepared for backfilling (upper left), the crater with fully cured foam backfill (upper right), the finished foam surface ready for capping (lower left), and the completed repair (lower right).

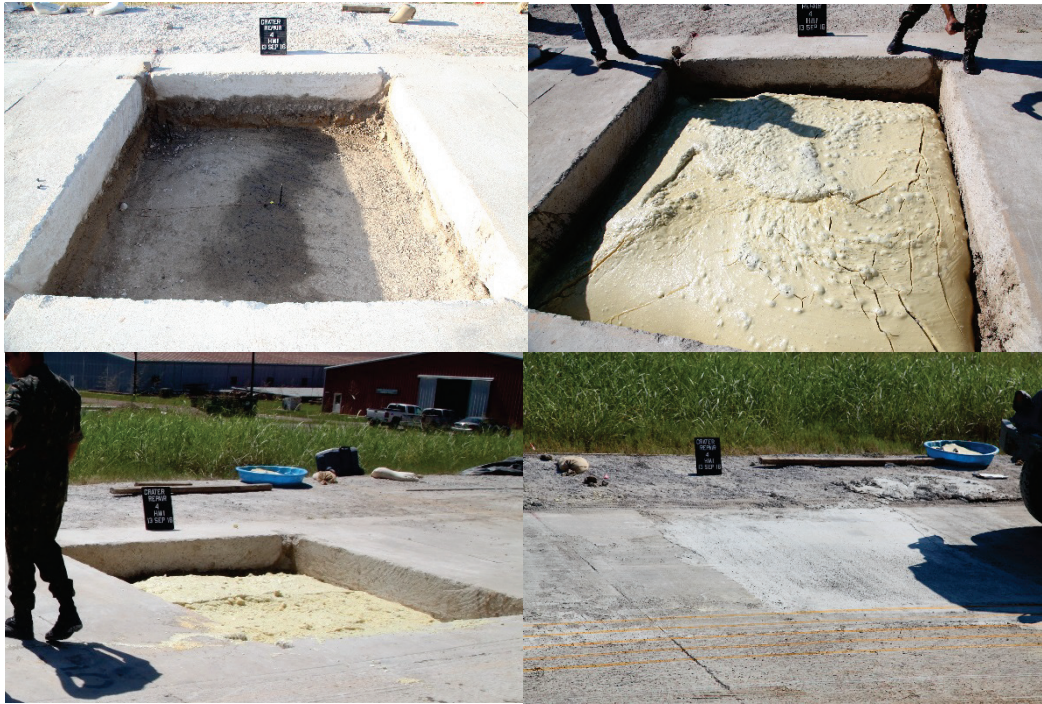
Figure 5.6. Repair sequence for Crater 4 including the crater prepared for backfilling (upper left), the crater with fully cured foam backfill (upper right), the finished foam surface ready for capping (lower left), and the completed repair (lower right).

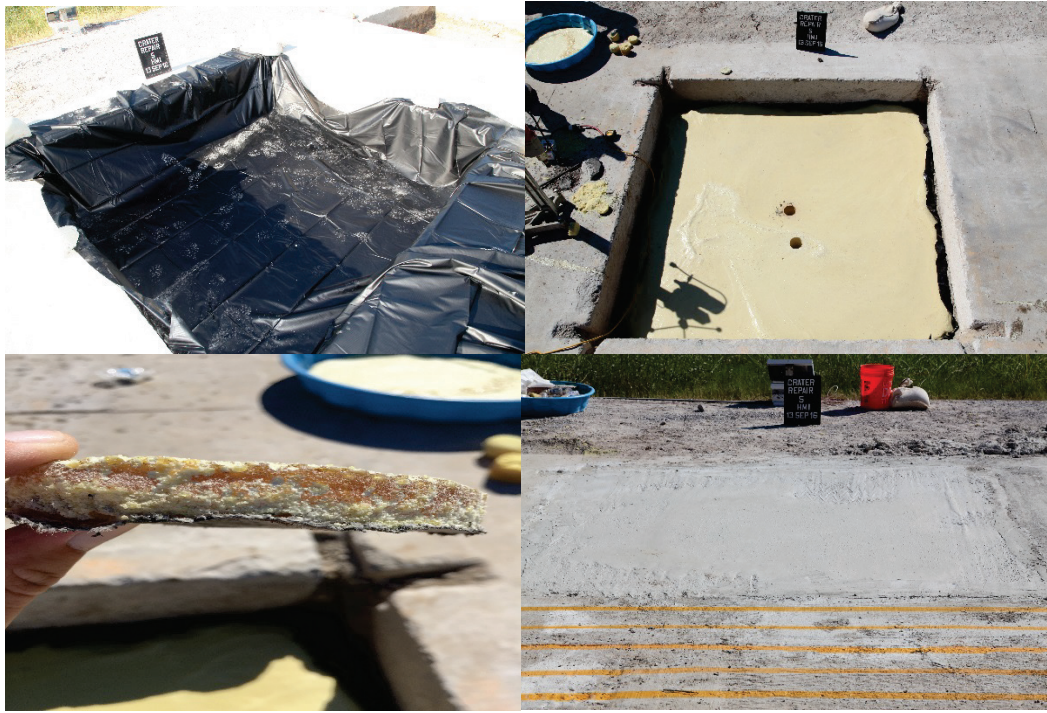
Figure 5.7. Repair sequence for Crater 5 including the crater prepared for backfilling (upper left), the crater with fully cured foam backfill (upper right), foam separation and solidification observed (lower left), and the completed repair (lower right).

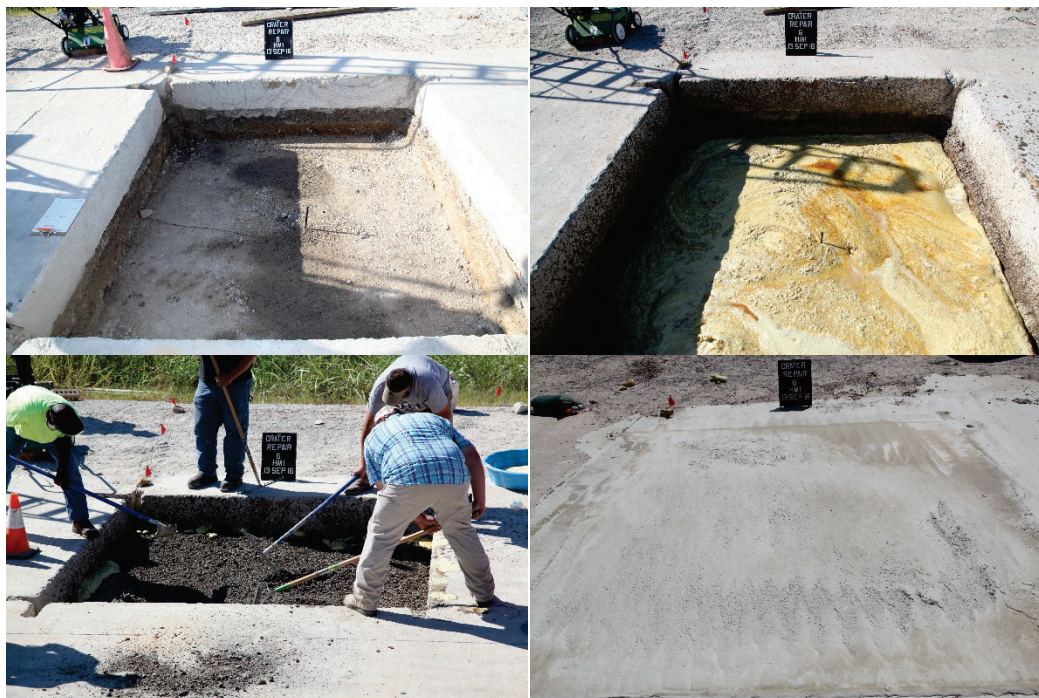
Figure 5.8. Repair sequence for Crater 6 including the crater prepared for backfilling (upper left), the crater with poorly mixed foam backfill (upper right), the crater with crushed limestone backfill (lower left), and the completed repair (lower right).

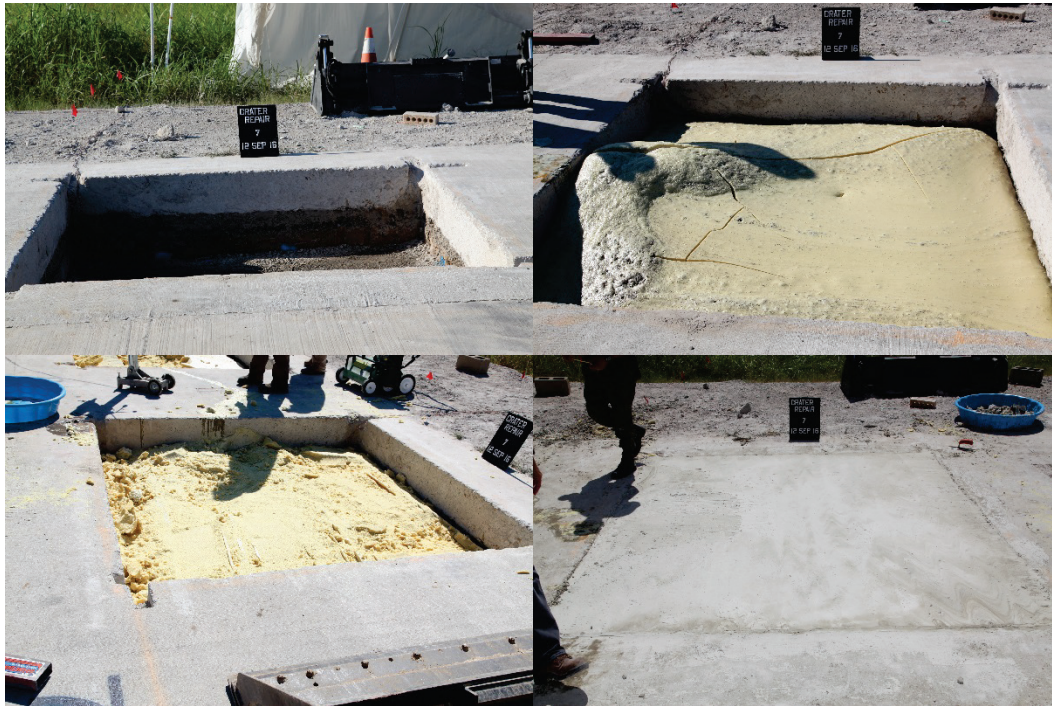
Figure 5.9. Repair sequence for Crater 7 including the crater prepared for backfilling (upper left), the crater with fully cured foam backfill (upper right), the finished foam surface ready for capping (lower left), and the completed repair (lower right).

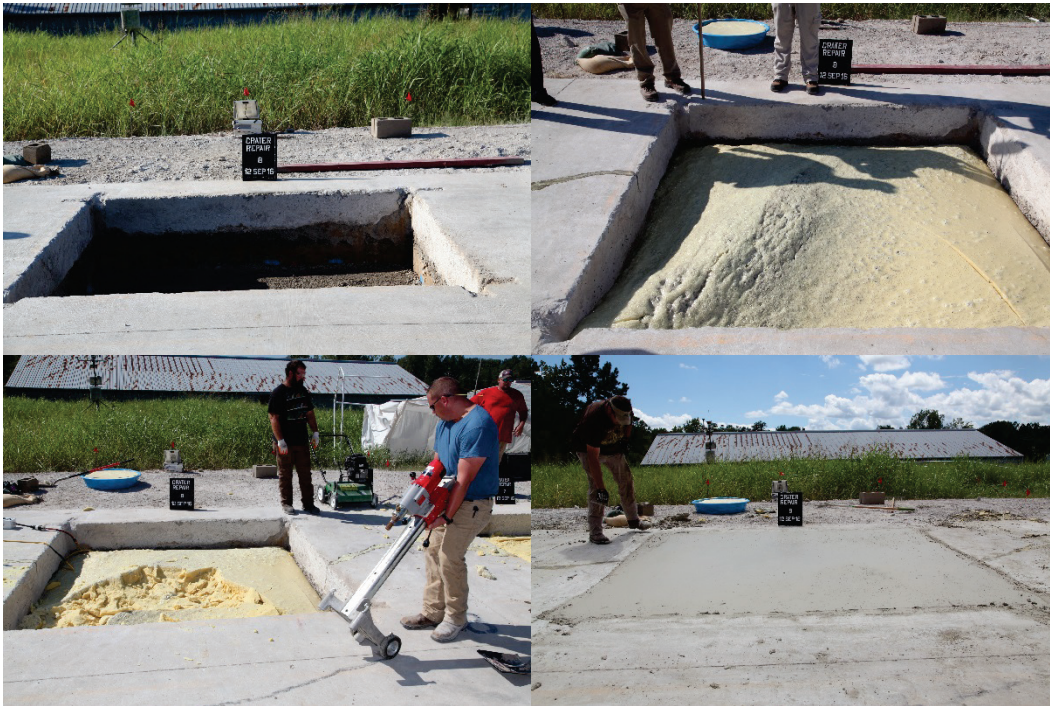
Figure 5.10. Repair sequence for Crater 8 including the crater prepared for backfilling (upper left), the crater with fully cured foam backfill (upper right), the finished foam surface ready for capping (lower left), and the completed repair (lower right).

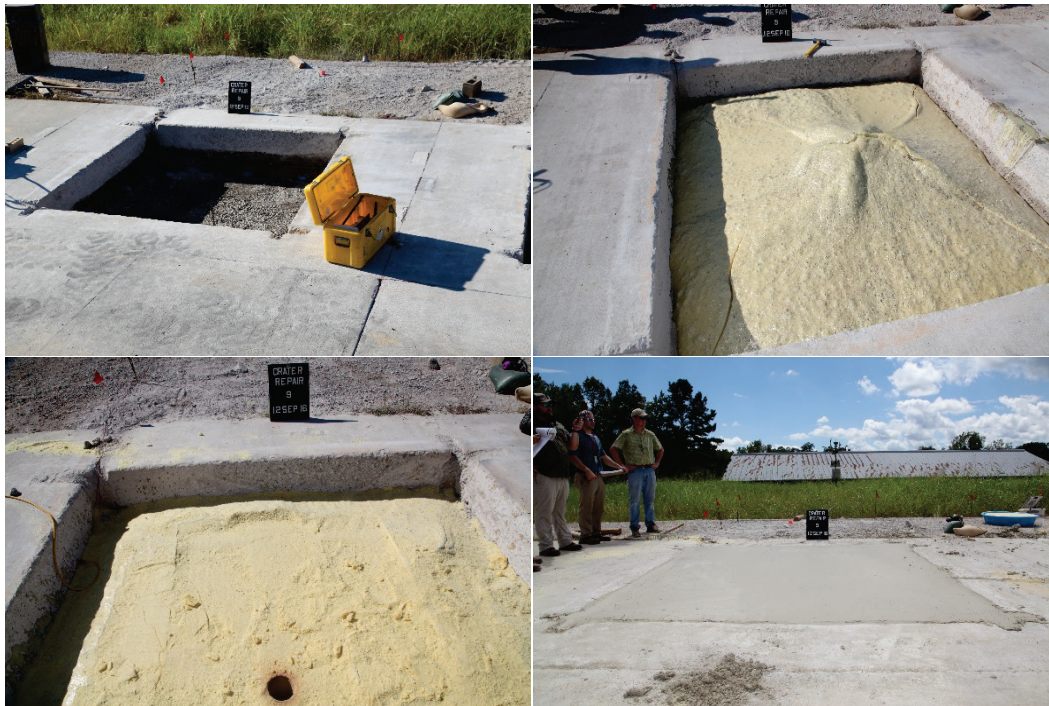
Figure 5.11. Repair sequence for Crater 9 including the crater prepared for backfilling (upper left), crater with fully cured foam backfill (upper right), finished foam surface ready for capping (lower left), and completed repair (lower right).

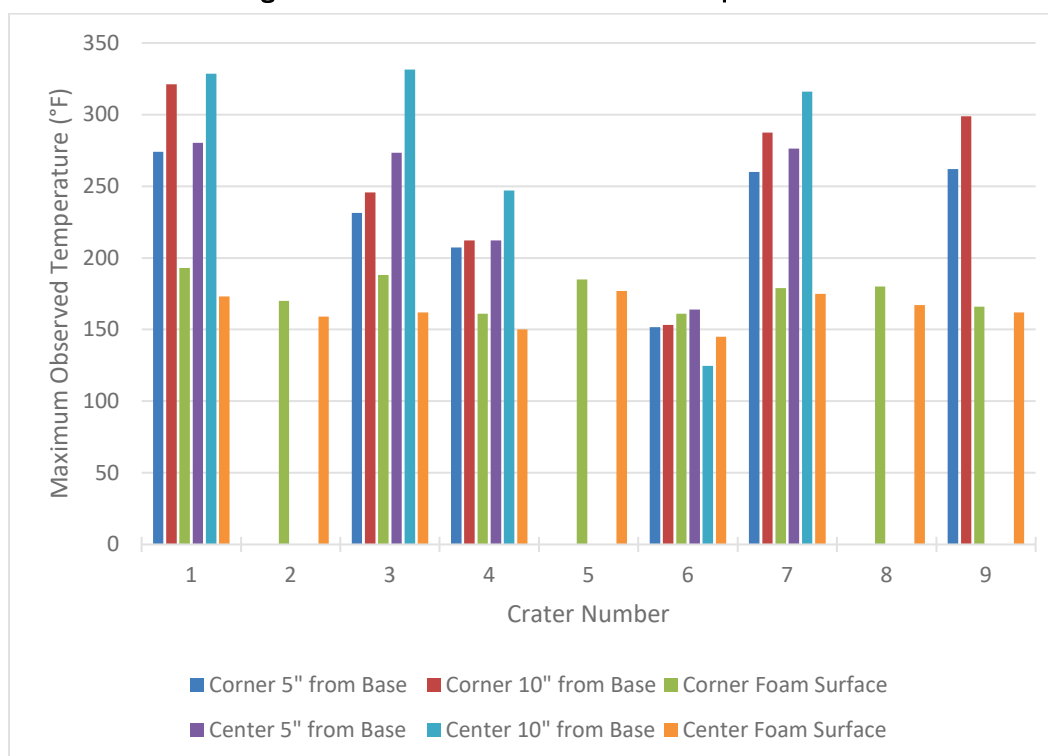
Figure 5.12. Maximum observed foam temperatures.

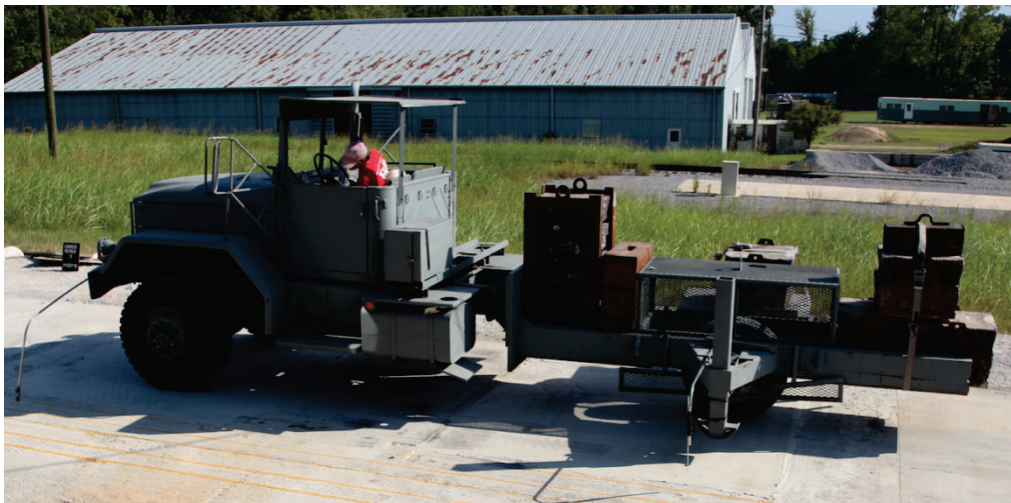
Figure 5.13. F-15E load cart.

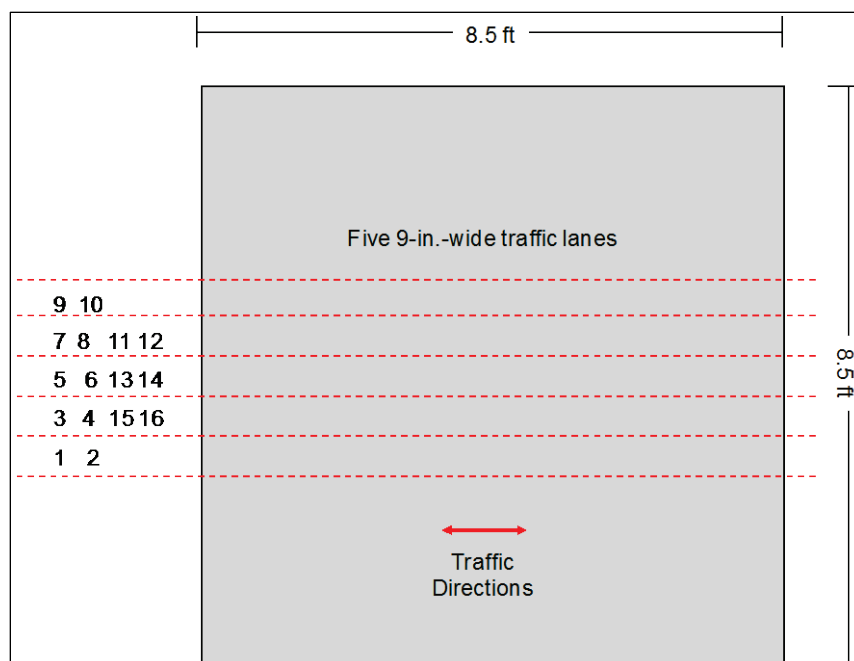
Figure 5.14. Typical F-15E load cart traffic pattern applied to repairs.

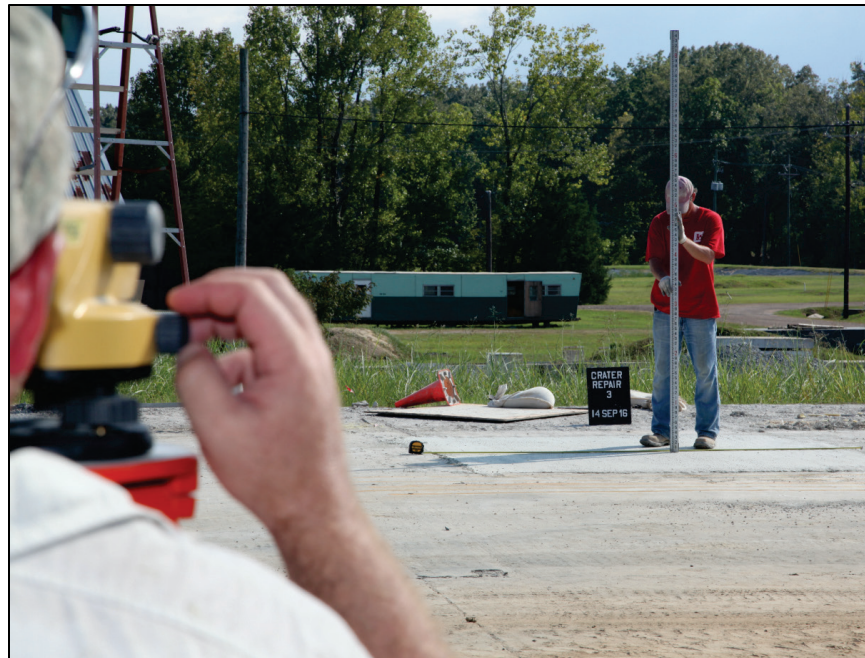
Figure 5.15. Rod and level measurements.

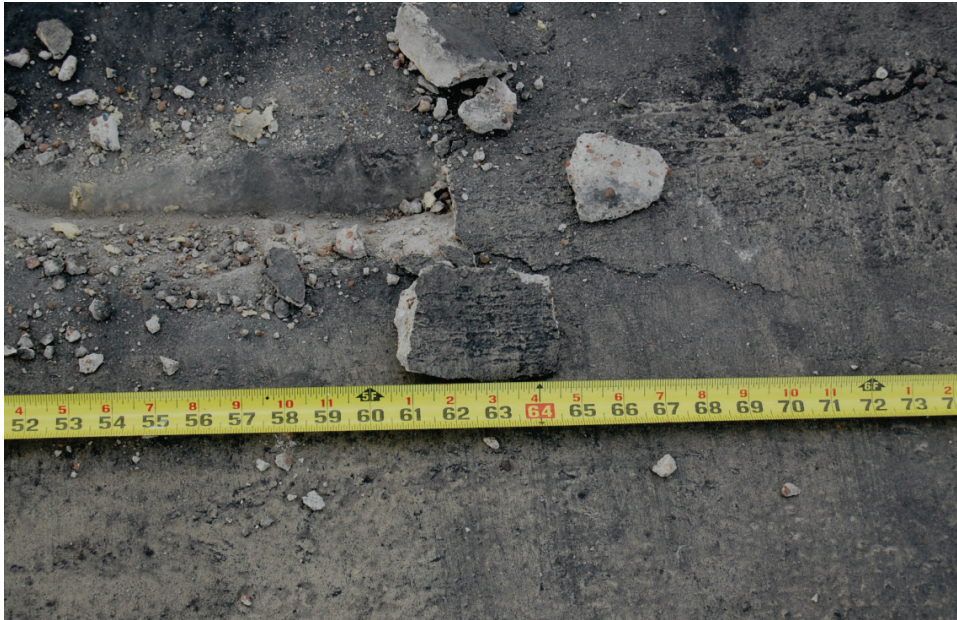
Figure 5.16. Typical failure mode of high-severity joint spall with high FOD potential.

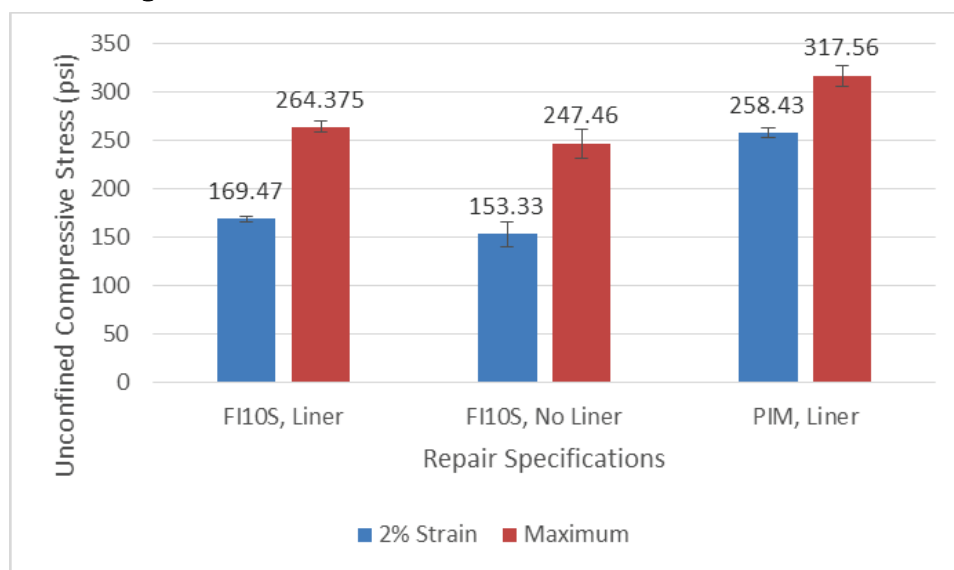
Figure 6.1. UCS of foam formulations with and without PVC liners.

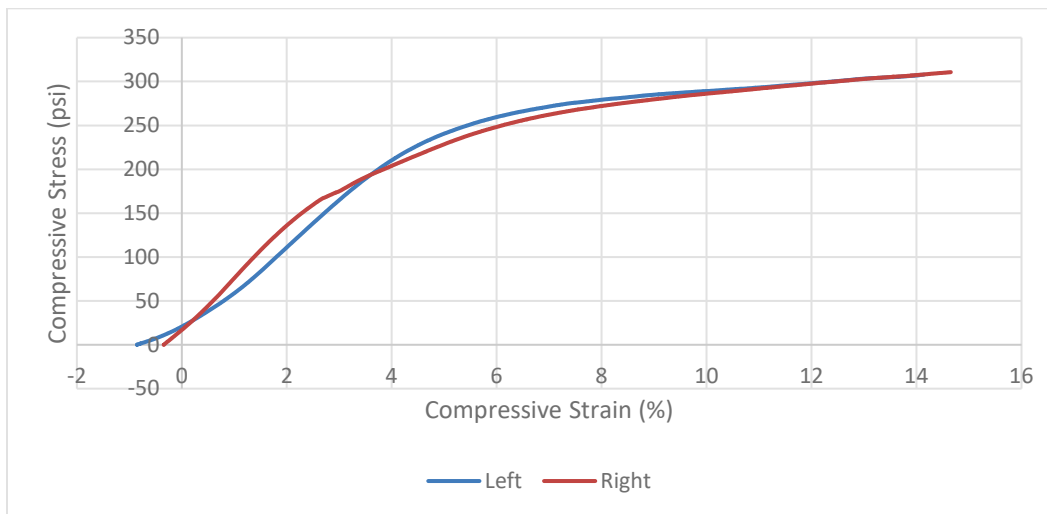
Figure B1. Average stress-strain curves for two foam samples in 20-gal trays shown in Figure 3.4.

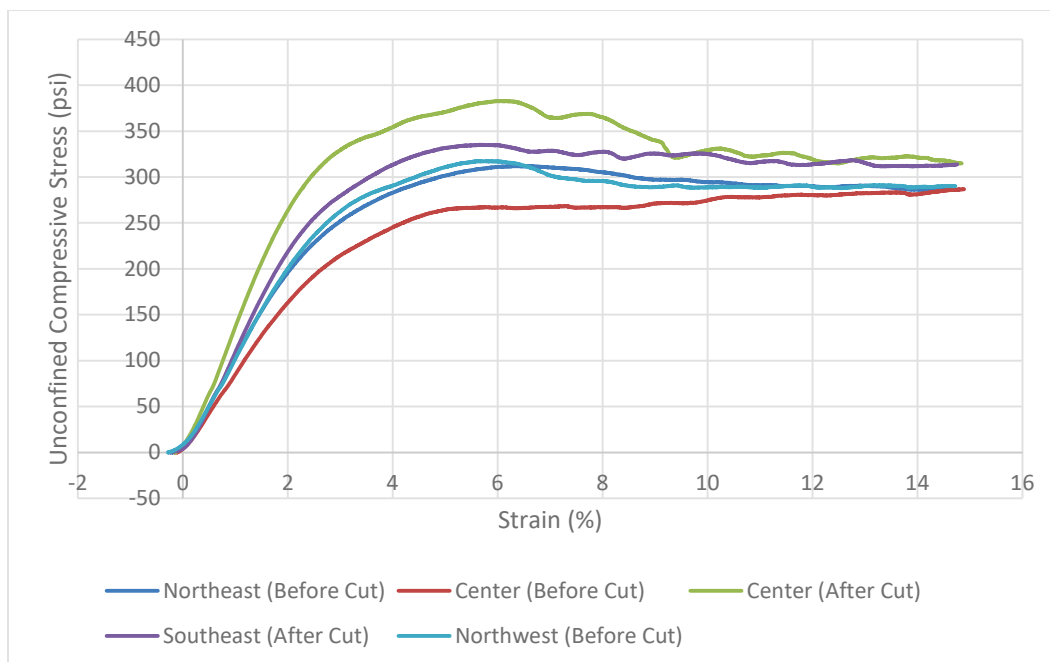
Figure B2. Stress-strain curves for 8-ft x 8-ft crater.

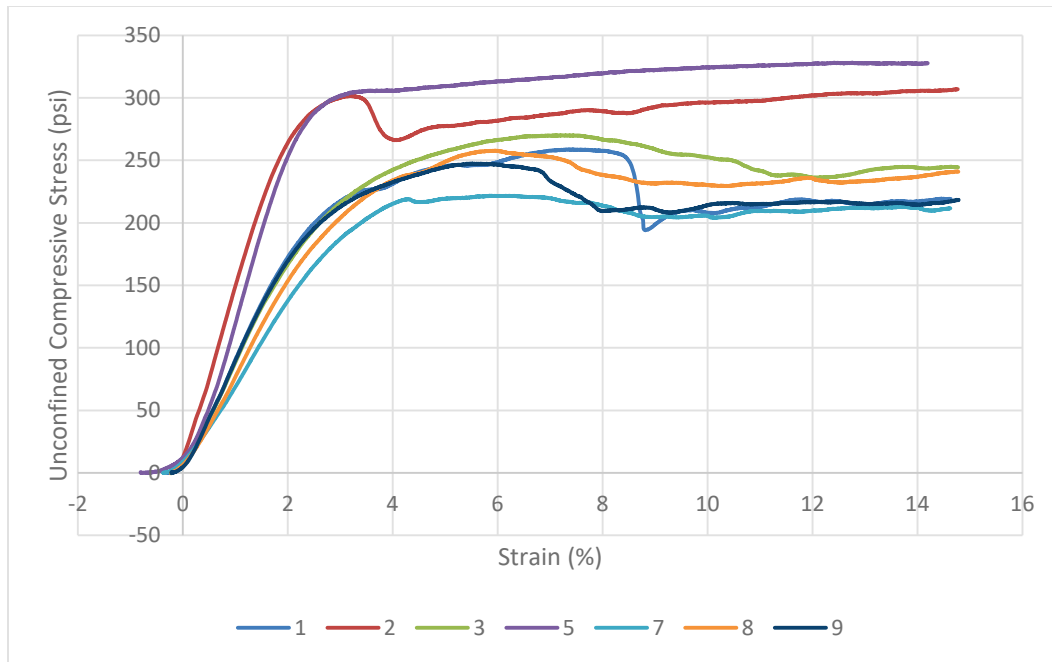
Figure B3. Stress-strain curves for full-scale demonstration.

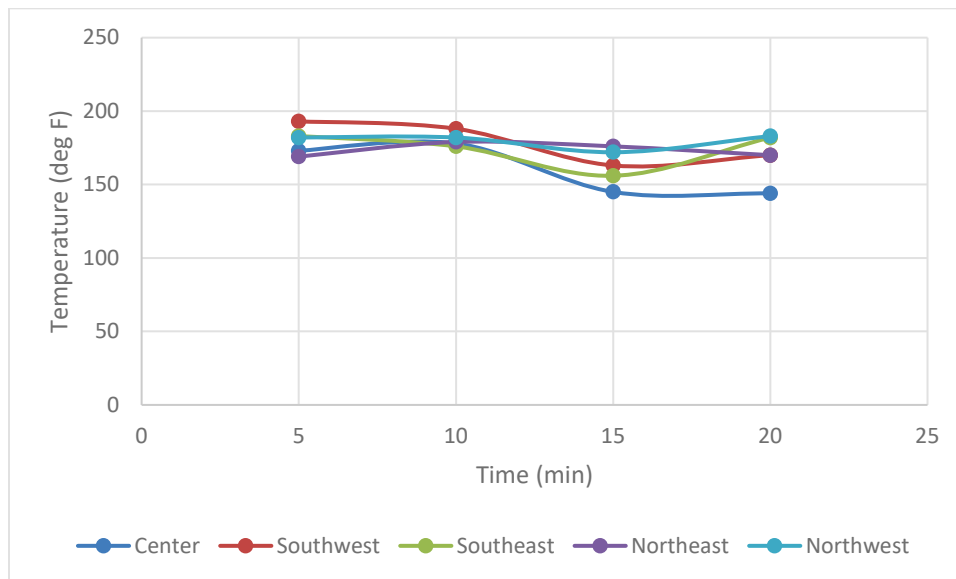
Figure C1. Crater 1 surface temperature data.

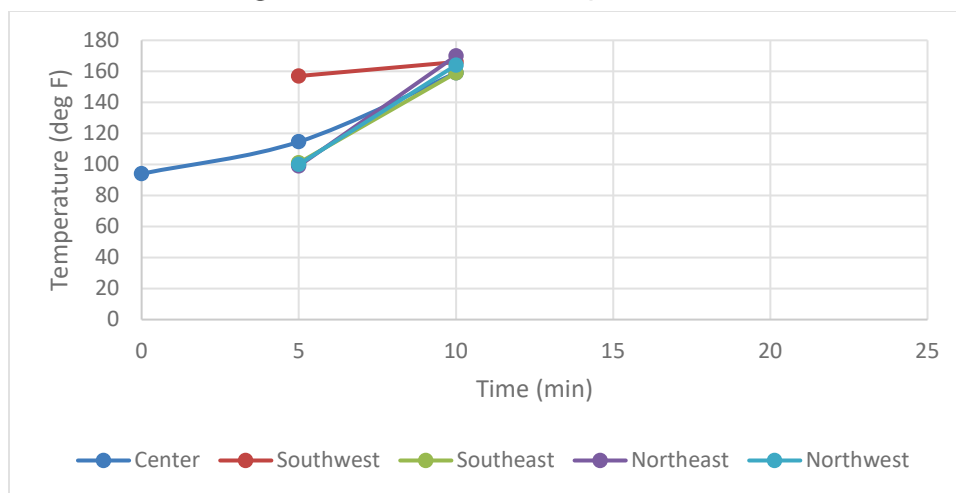
Figure C2. Crater 2 surface temperature data.

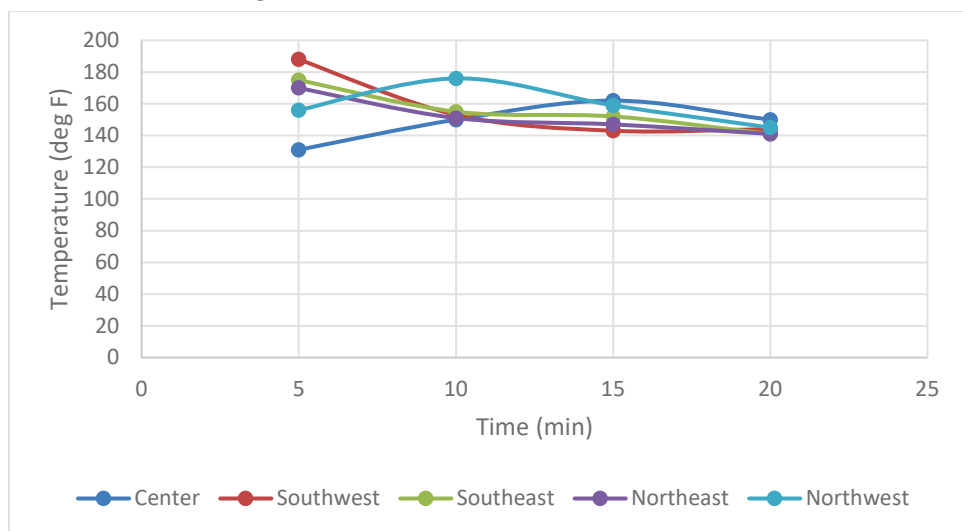
Figure C3. Crater 3 surface temperature data.

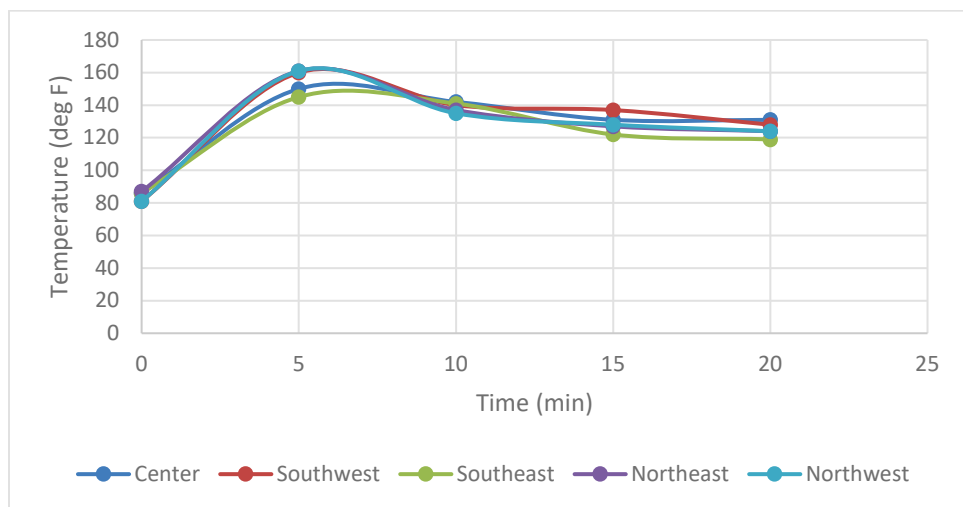
Figure C4. Crater 4 surface temperature data.

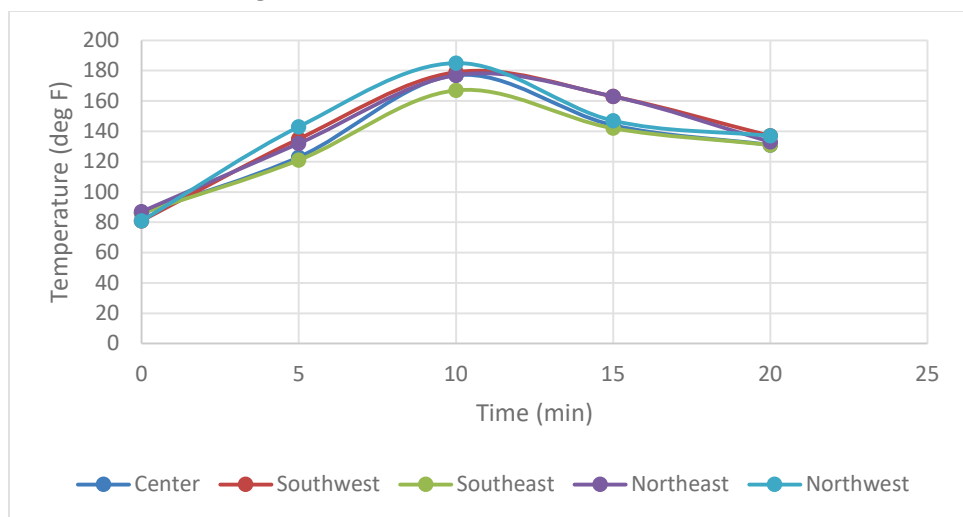
Figure C5. Crater 5 surface temperature data.

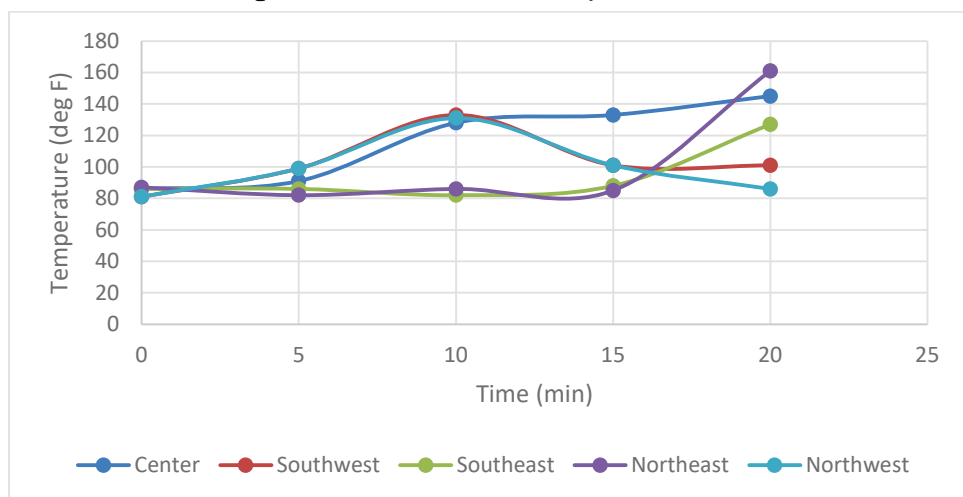
Figure C6. Crater 6 surface temperature data.

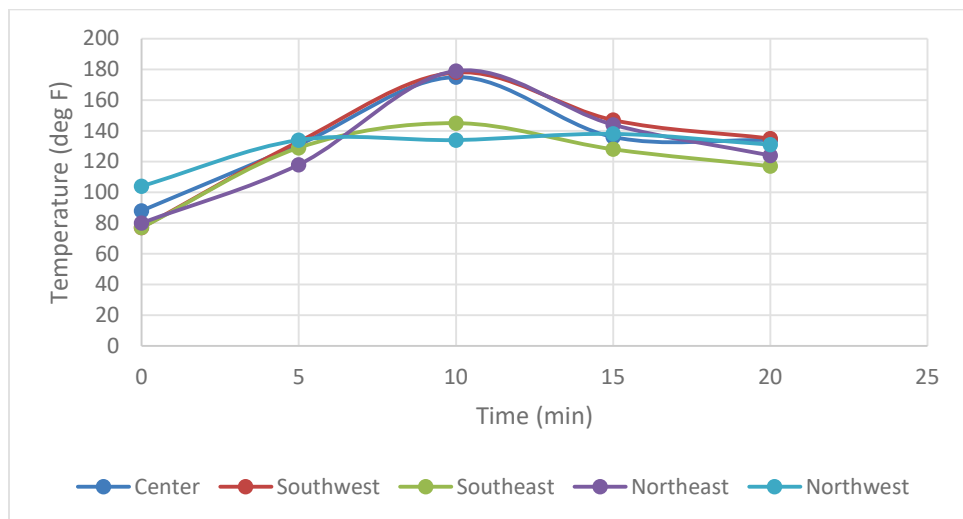
Figure C7. Crater 7 surface temperature data.

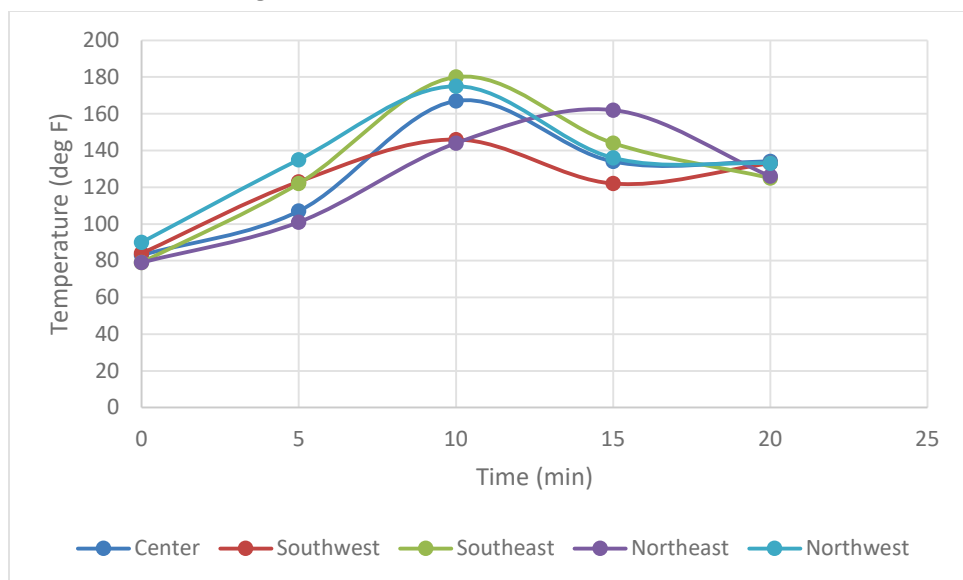
Figure C8. Crater 8 surface temperature data.

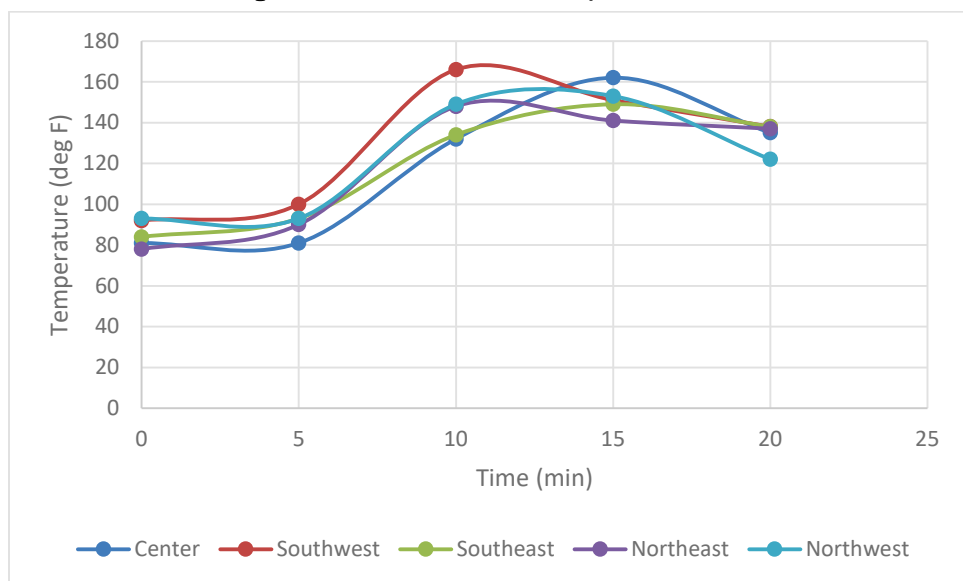
Figure C9. Crater 9 surface temperature data.

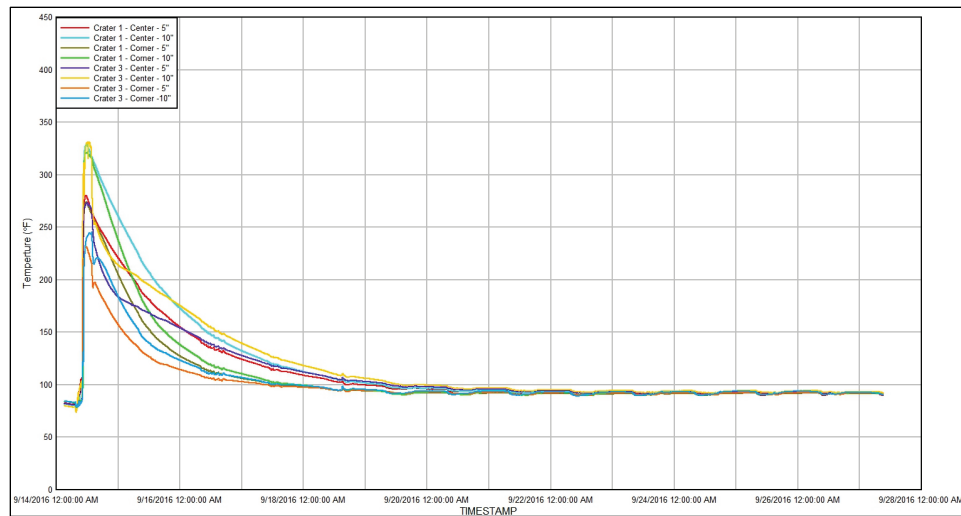
Figure C10. Craters 1 and 3 – internal foam temperature data.

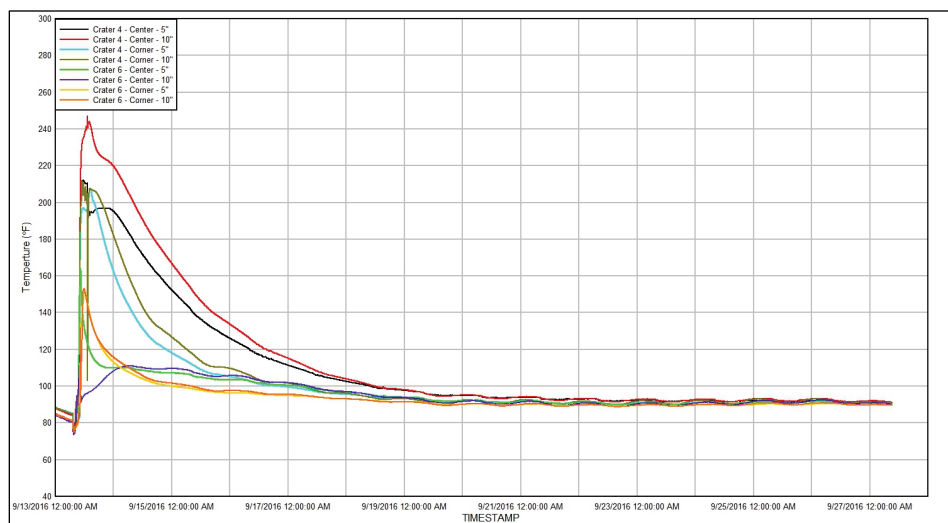
Figure C11. Craters 4 and 6 – internal foam temperature data.

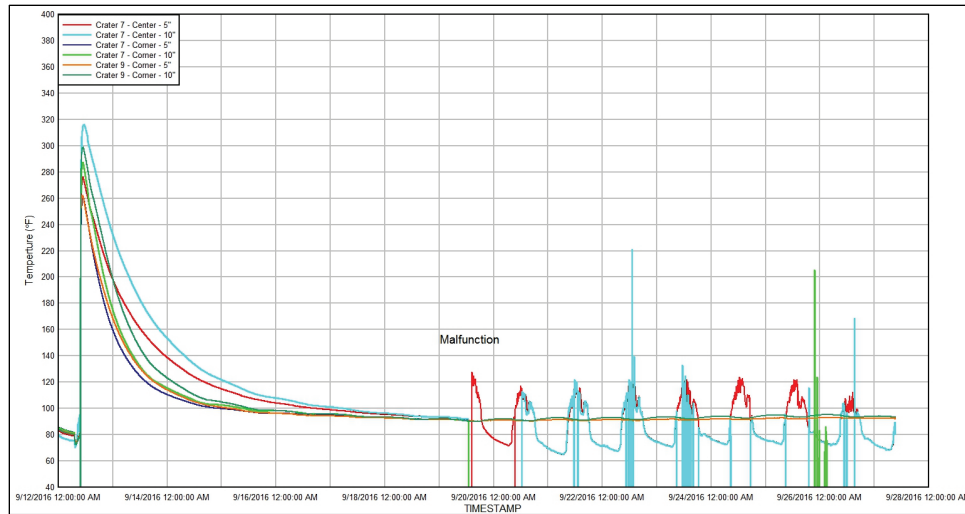
Figure C12. Craters 7 and 9 – internal foam temperature data.

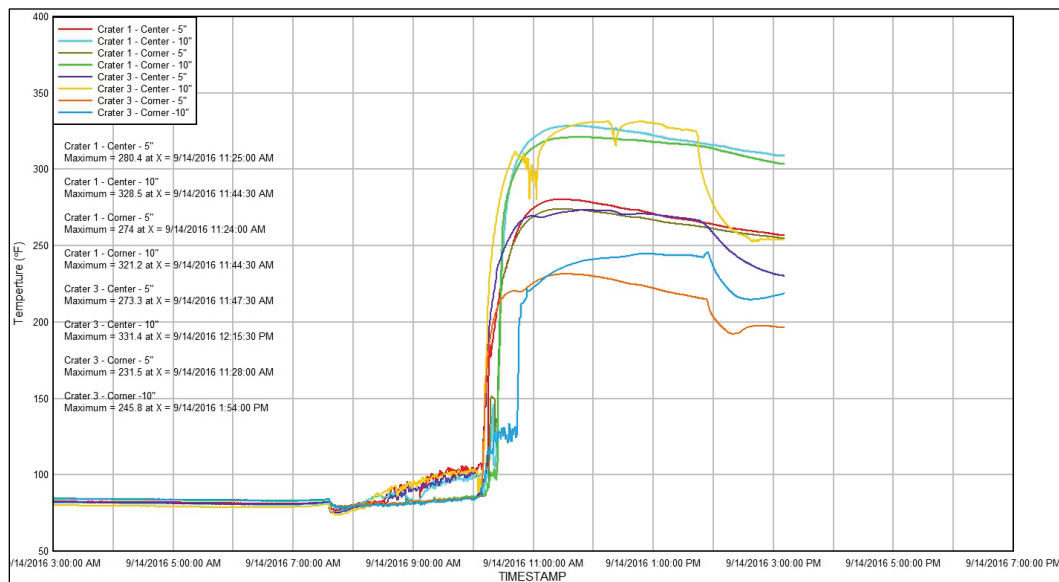
Figure C13. Craters 1 and 3 – internal foam temperature trend and maximum.

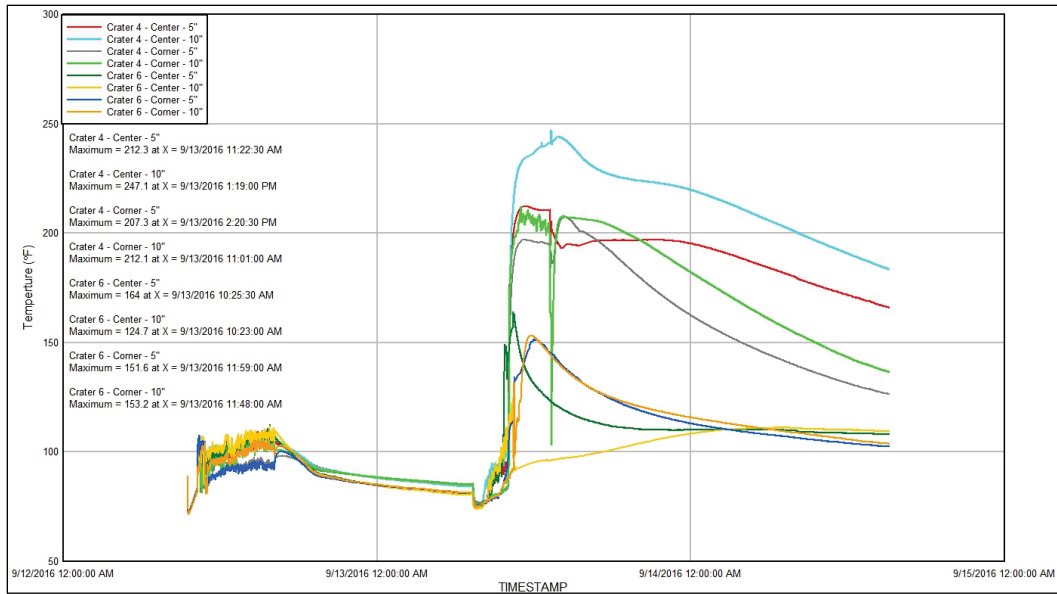
Figure C14. Craters 4 and 6 – internal foam temperature trend and maximum.

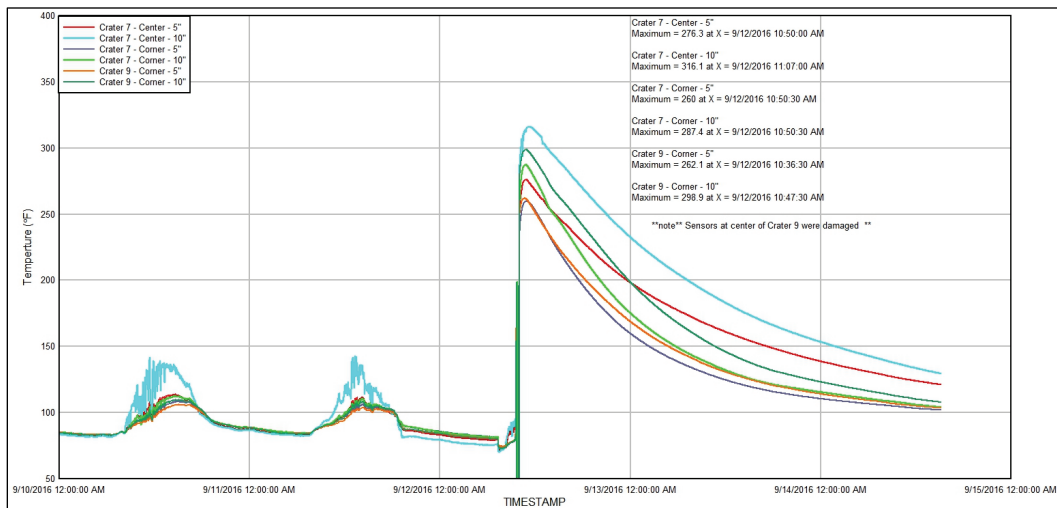
Figure C15. Craters 7 and 9 – internal foam temperature trend and maximum.
